Wall heating

System E-ENERGY CARBON FLEECE

Restoration of the Zweibrücker Castle in 55571 Odernheim am Glan

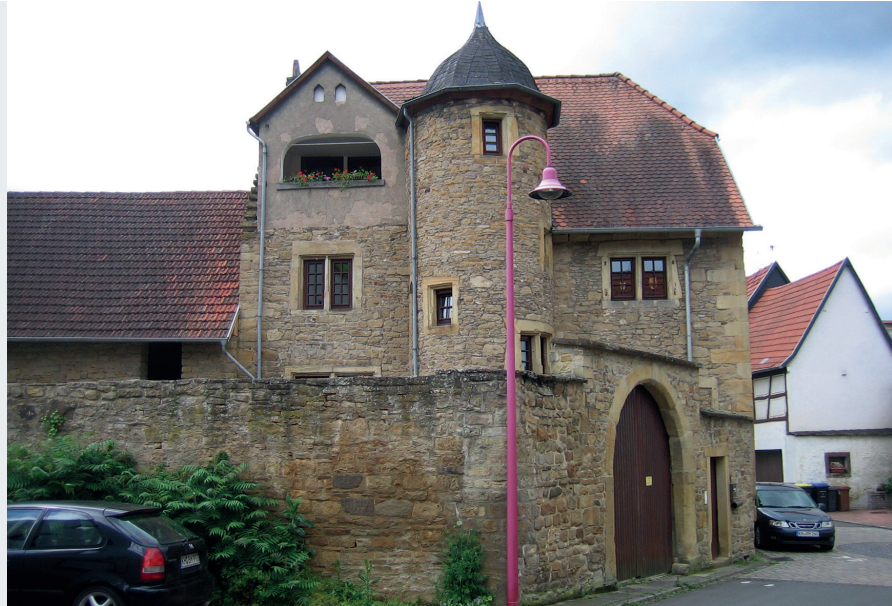
In the unheated stair tower, the warm and humid air from the apartments condensed on the cold walls and led to a mould problem. Due to the limited space caused by the regulations for the protection of historical monuments, the E-ENERGY CARBON FLEECE system with $220 \text{ W} / \text{m}^2$ was used.

Wall covering	Fine putty
Surface heating	E-ENERGY CARBON FLEECE
Surface	21 m ²
Area	Stair tower

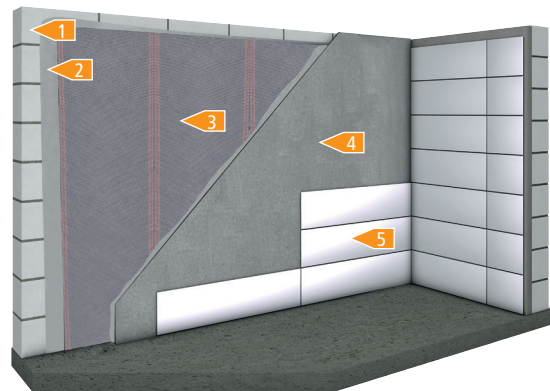
Construction

- 1 Raw wall
- 2 Putty
- 3 E-ENERGY CARBON FLEECE
- 4 Fine putty
- 5 Painting, wallpaper, tiles

1 mm
0,4 mm
2 mm
4 mm
